# Effective removal of spinning contaminants

## Ragger

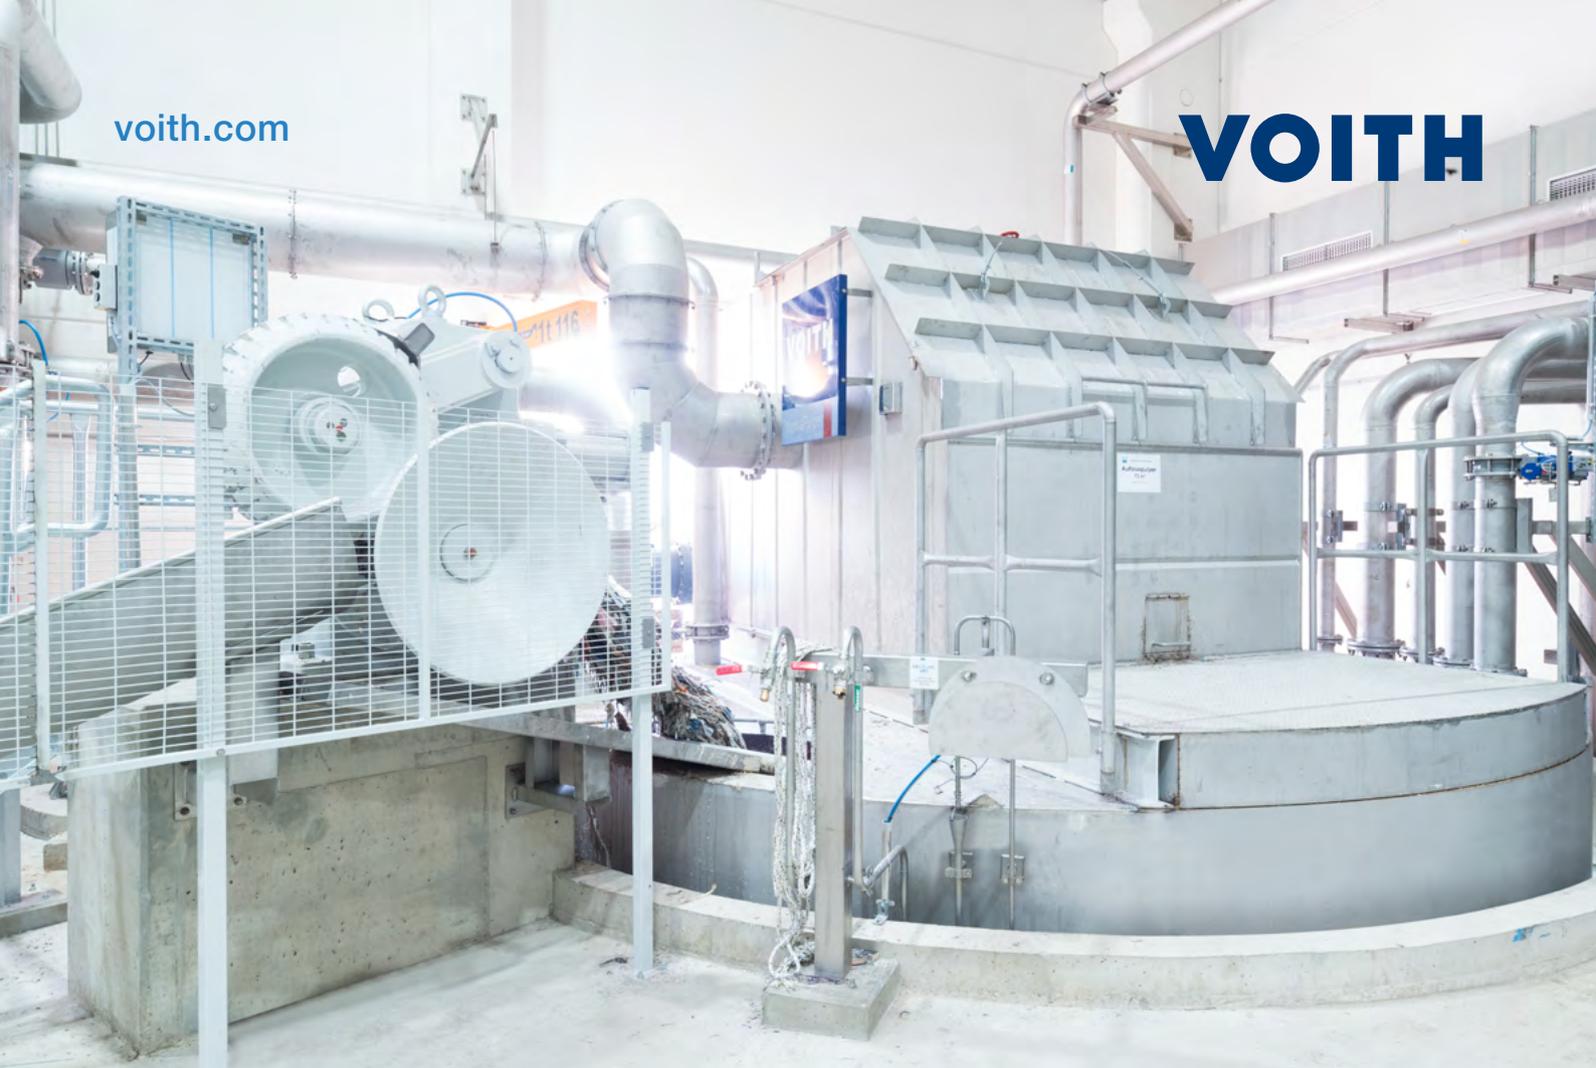
In conjunction with the IntensaPulper IP-R, the ragger transports the tail, formed from bale wires and other coarse spinning contaminants contained in the recovered paper, from the IntensaPulper. To form a sufficiently stable tail, a sufficient quantity of contaminants, such as typically occur in the OCC raw material need to be continuously fed to the IntensaPulper IP-R.

The ragger produces 1.6 tons of tractive force with a 1.1 kW motor. During breaks in operation the brake integrated into the motor stops the transport wheel from twisting. Forward and backward transportation of the ragger is possible with push buttons. The high gear ratio allows an intermittent speed control from 10 to 300 m/h.

Correctly positioned and in combination with the rotor of the IntensaPulper IP-R, the number of torn off tails can be reduced to a minimum. Strong ribs on the transport wheel prevent slippage.

Due to irregularities from raw material or variations in the contaminant content, the diameter of the ragger tail will go up and down. The tail diameter and/or fluctuations are displayed in the DCS. Major changes in diameter that lead to the tail slipping on the transport wheel are detected by a controller which often rectifies the malfunction immediately.
